A Pericardium Membrane powered by  
GLYMATRIX® Technology

**Dr. Theofilos Koutouzis, DMD MS**  
Periodontist  
Private clinic, Florida, US

## Ridge Augmentation following implant removal due to peri-implant disease

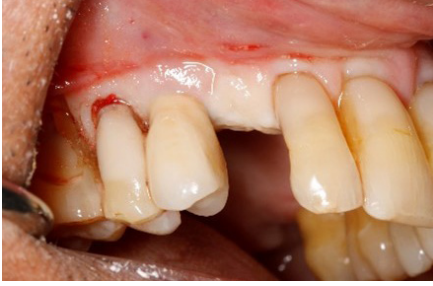
1. Facial view of an edentulous ridge and a failed implant

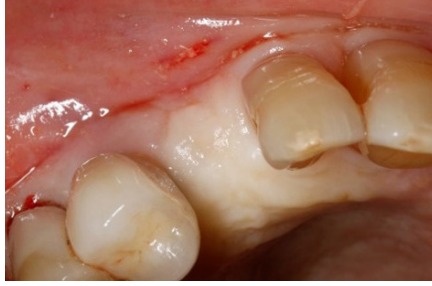
2. Occlusal view of an edentulous ridge and a failed implant

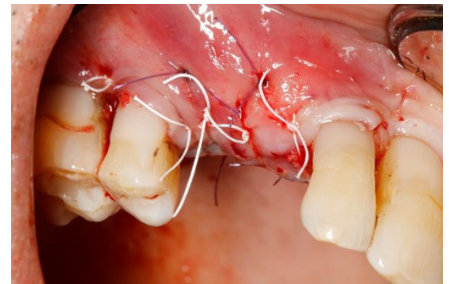
6. Facial view following suturing

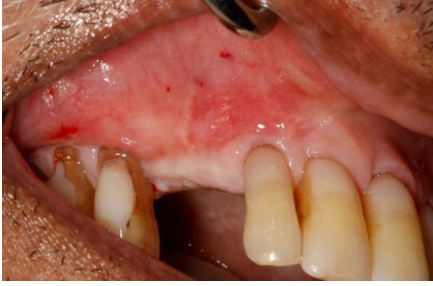
**1.** Facial view of the regenerated ridge, prior to flap elevation

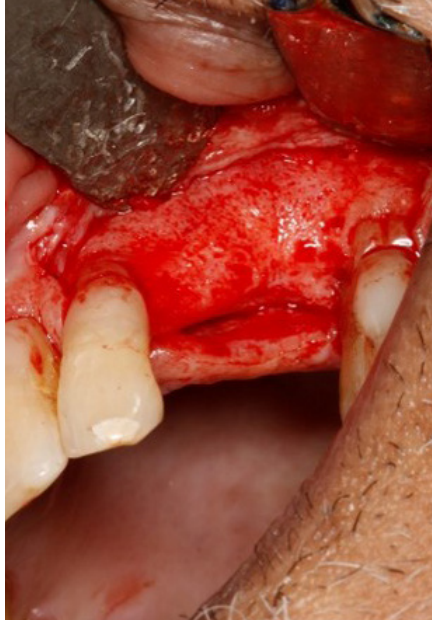
**2.** Facial view of the regenerated area
